DRAFT

Report by: Scott L. Turner

Case Caption: Paul Goodman, et al v. Dillon Transportation, LLC

Equipment Involved: Defendant: 2006 Great Dane Lowboy type Semi-Trailer
VIN: 1GRAA06267B705402
GVWR: 55,000

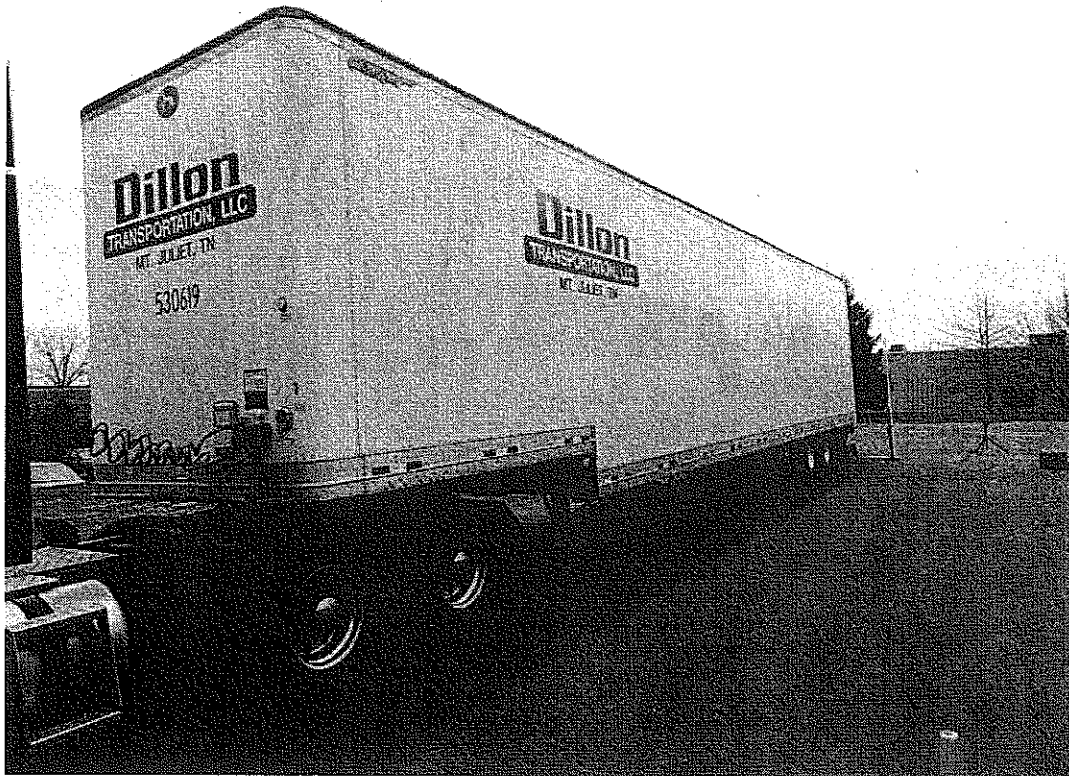
Photo #1

Once the raising is complete and the kickstand legs are inspected for proper positioning by the CMV driver, the driver/operator can then back to the loading dock to be loaded or offloaded with the assigned freight.

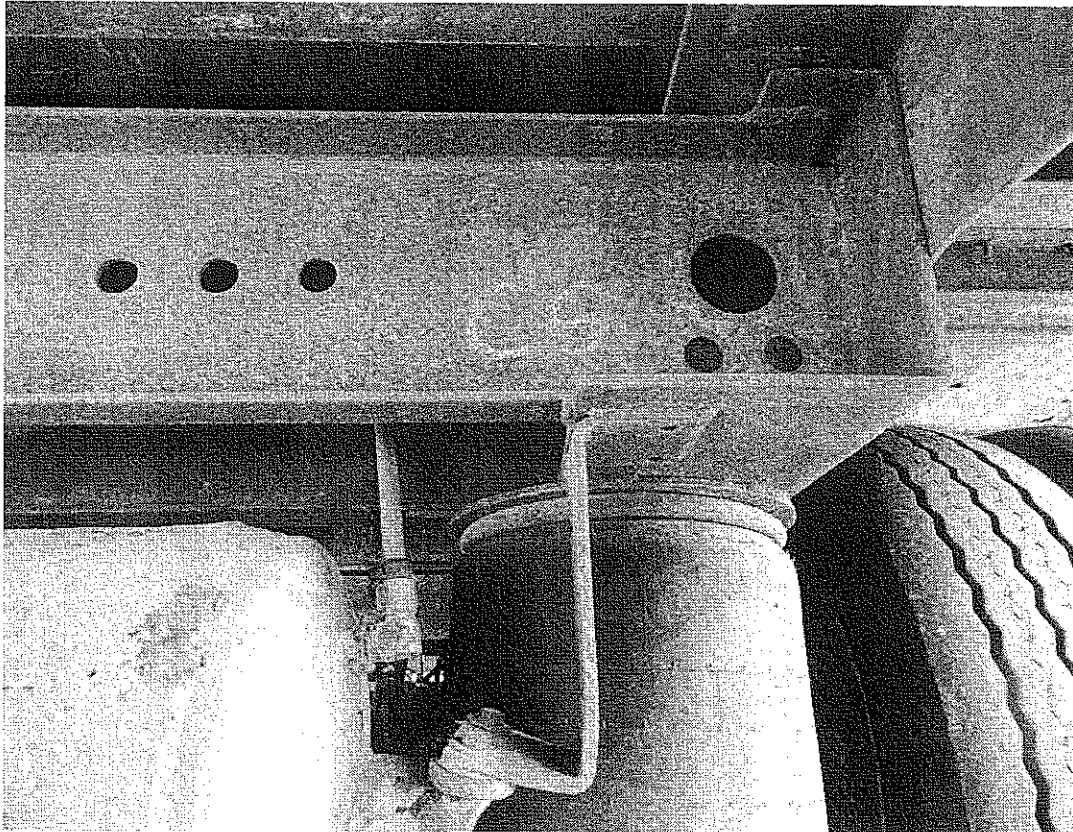
Photo #2

The above photo depicts in-part the air-ride suspension system that engages once the CMV is traveling on a roadway, or traveling in general.

This same air-ride system serves a dual purpose, it provides for the elevation required to engage the kickstand legs onto the axle to provide for rigid support allowing the trailer to be safely loaded/off-loaded at a loading dock.

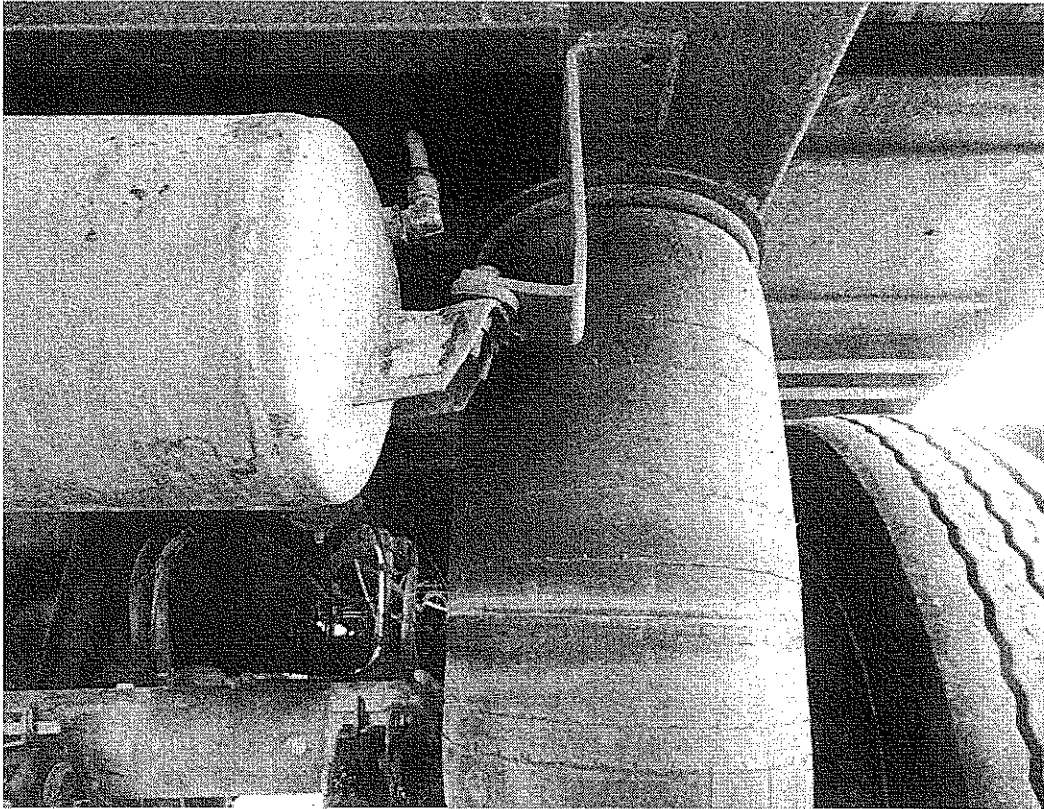
Photo #3

The following photograph demonstrates the same airbag that is utilized, however, fully inflated to elevate the back-end of the semi-trailer to meet the required dock height of which is typical from 3'6" to 4'2".

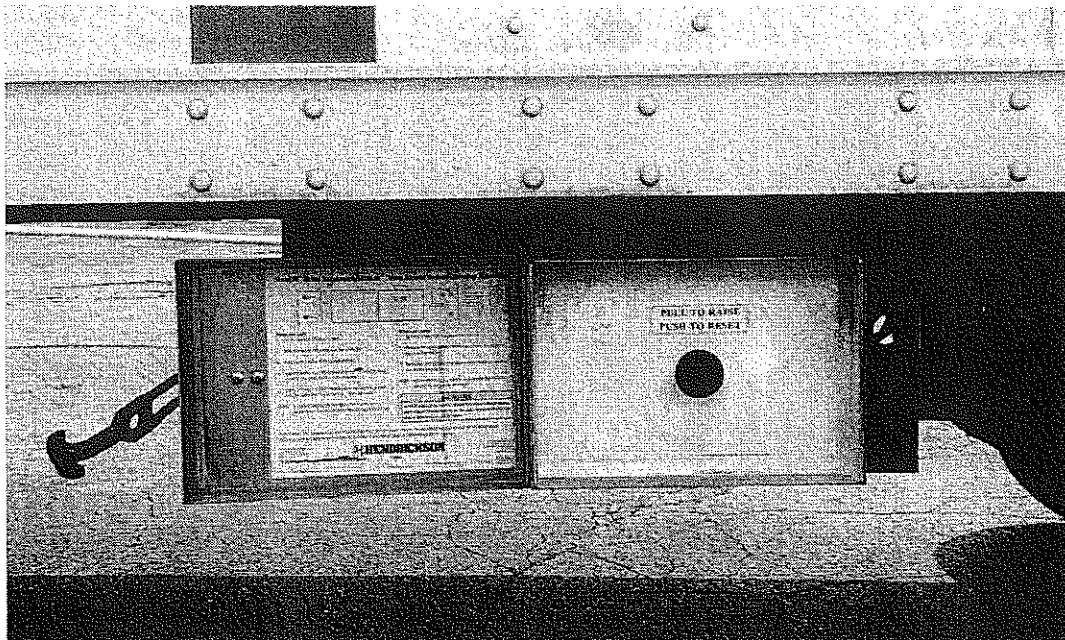
Photo #4

The way the system works is the airbags are inflated, once the CMV operator follows a specific protocol regarding the semi-trailer parking brake system. The system functions by applying the black air valve located on the side of the semi-trailer, driver-side.

In the control box next to the black air-valve located on the driver's side of the semi-trailer, near the semi-trailer tires, once the Maxi-Lok control box is opened, to the left is a set of very explicit instructions on how to operate the Maxi-Lok system (see Photo #4).

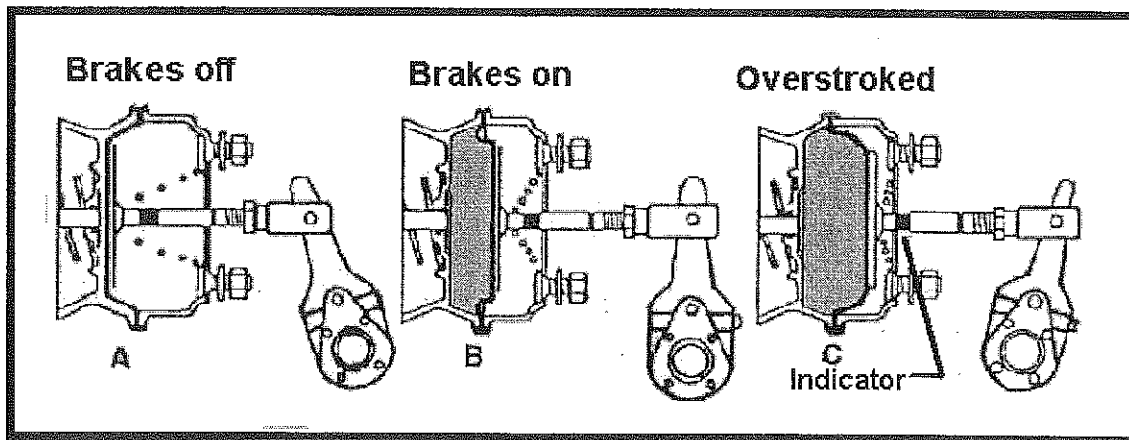
The above image demonstrates an air chamber that has a pushrod originating from its center whereby it attaches to a slack adjuster rod by a clevis, this is the only difference.

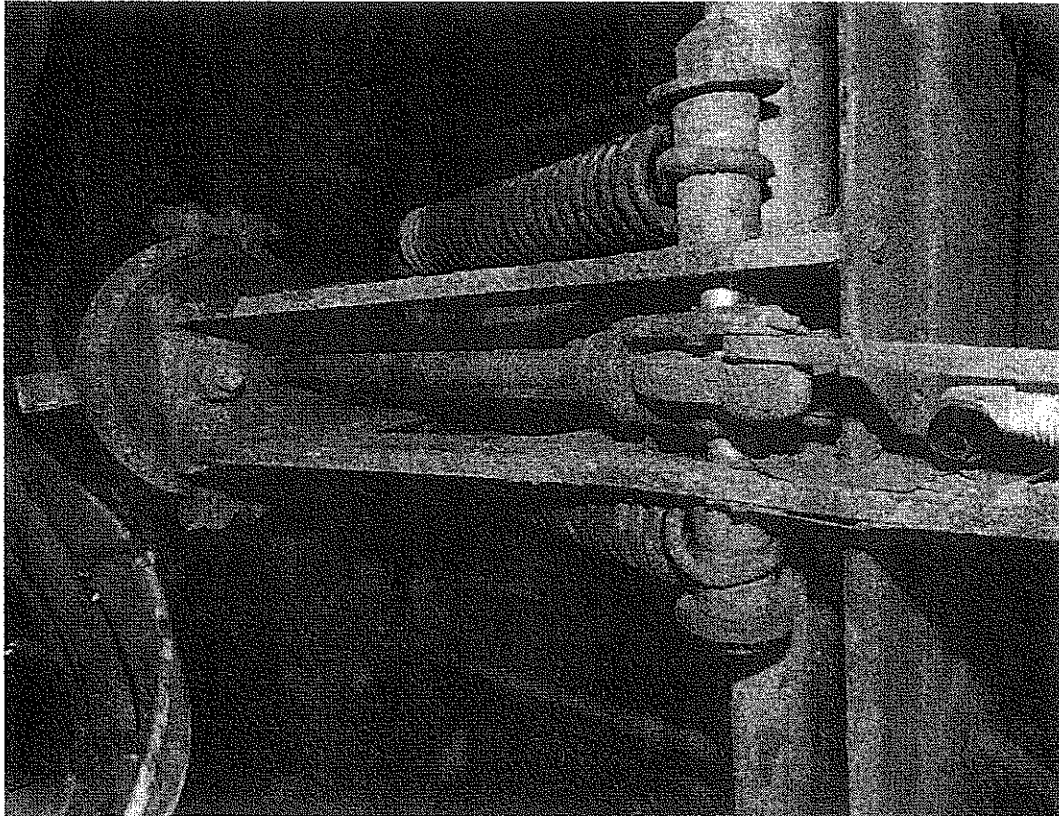
Photo #5

Although it may be somewhat difficult for the layperson's eye to discern exactly what the following photograph demonstrates, it is merely the pushrod coming out of the air chamber that connects to the shaft that ultimately controls the up or down movement of the kickstand legs.

When the CMV driver applies the black air-valve on the side of the semi-trailer, the pushrod is mechanically pushed out of the chamber where the air pressure has been converted to mechanical energy.

When the kickstand legs are to be retracted back to their stowed position for operation on public roads, the springs noted in photo #5 pull the kickstand legs back to their stowed position, parallel to the roadway. This is after the black air valve is depressed by the driver/operator, the air springs (air bags) re-inflate allowing the wear pads to clear the axle, the semi-trailer then resettles back to its road ready position.

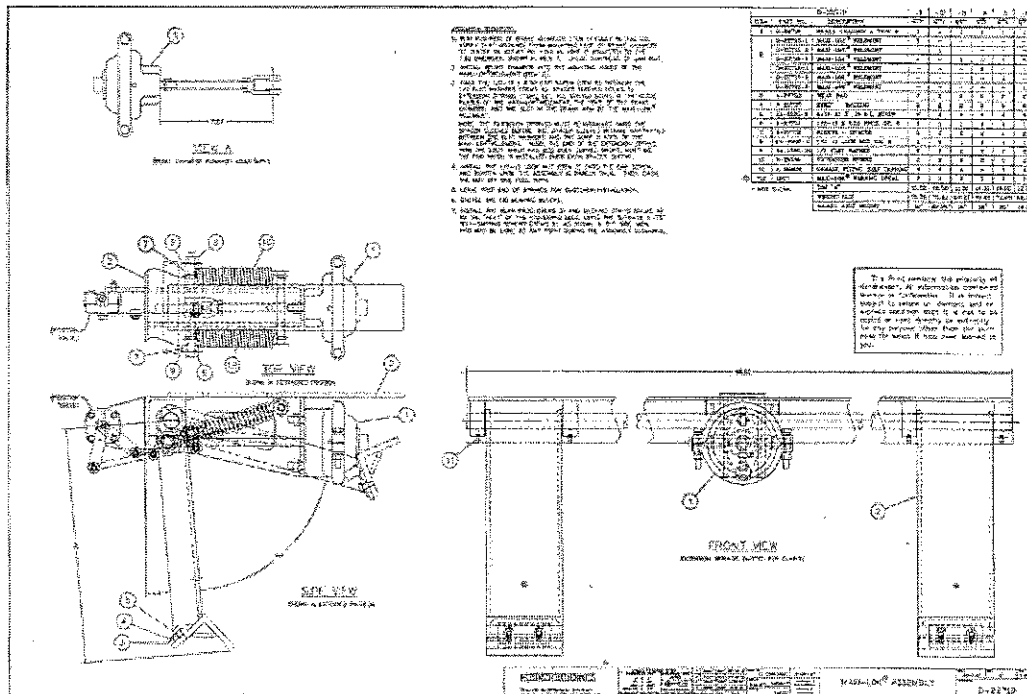
The kickstand legs begin in a parallel to the roadway position in their stowed position, once applied onto the axle they have partially circumferentially rotated approximately ninety degrees. In the kickstand's application position it is divergent to their stowed position whereas it is at a right-angle to the roadway surface while in its support mode sitting on the #2 axle of the semi-trailer.

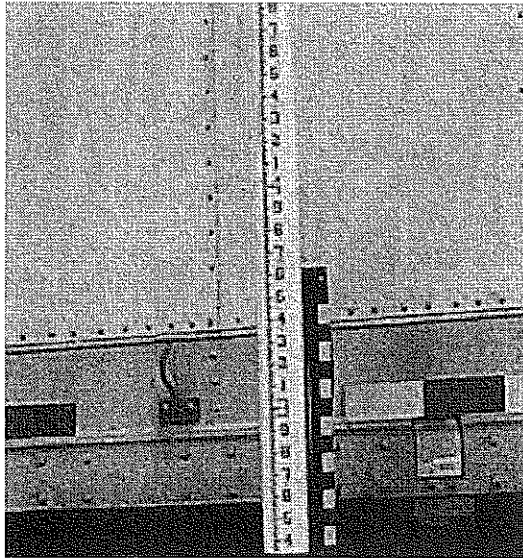
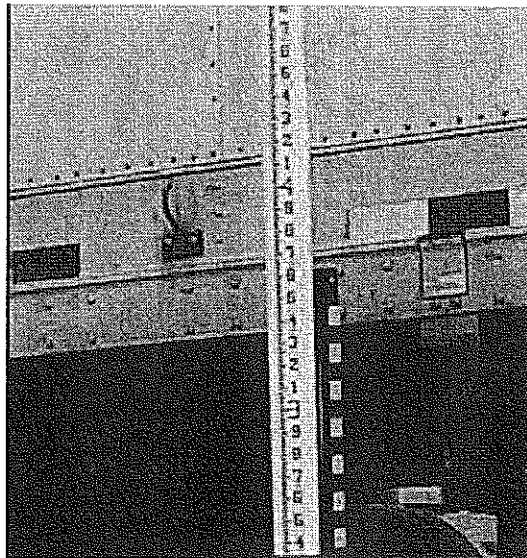
Photo #6

It is clear to see that the trailer elevates at a minimum of approximately 10". Based on that fact, without the primary and only support mechanism properly applied, – the kickstand legs – the semi-trailer is prone to a rapid and precipitous collapse as the air deflates from the airbags once the kickstand legs are supporting the semi-trailer while resting on the semi-trailer's #2 axle.

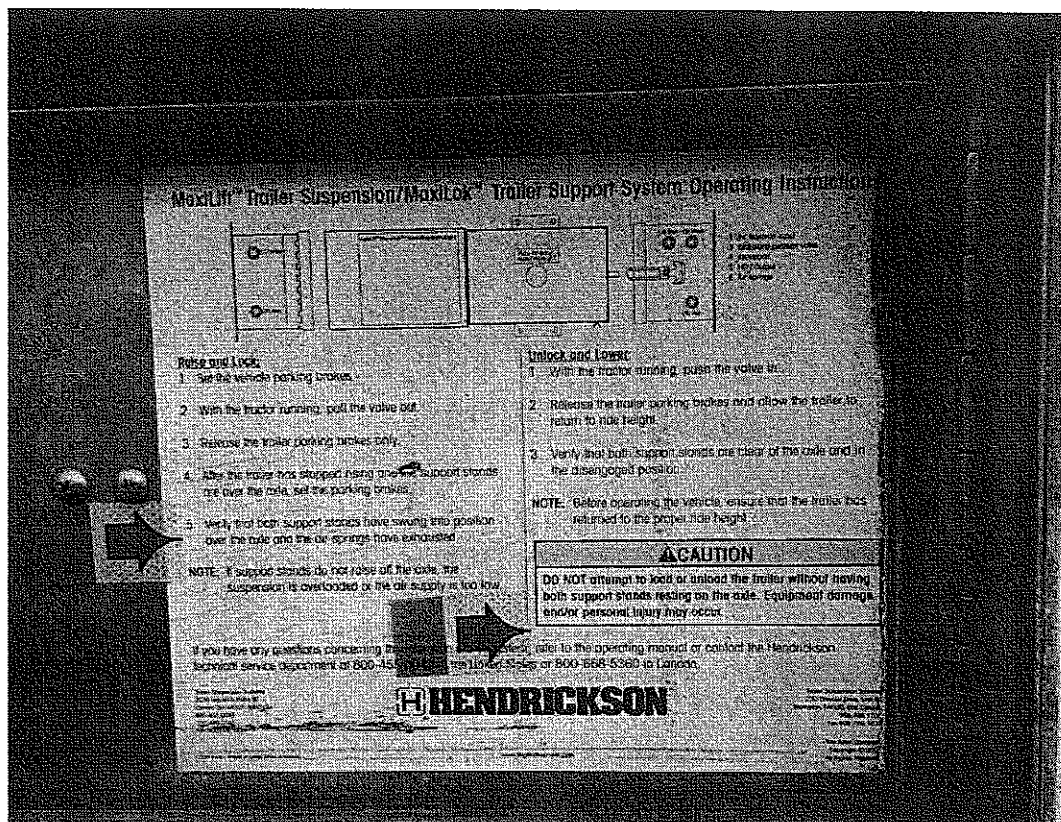
Photo #8

Note the two red arrows placed by SLTC for the purposes of highlighting the principal points. They state as follows:

- *“Verify that both support stands have swung into position over the axle and the air springs have exhausted.”*
- *“**Caution** – Do not attempt to load or unload the trailer without having both support stands resting on the axle. Equipment damage and/or personal injury may occur.”*

Clearly, if the only option for failure of the system is failure of the operator/driver to inspect prior to permitting activity in the back of his CMV, causation becomes a stand alone issue: the driver failed to inspect to insure the kickstand legs were fully applied whereas the wear pads were sitting firmly on the axle.

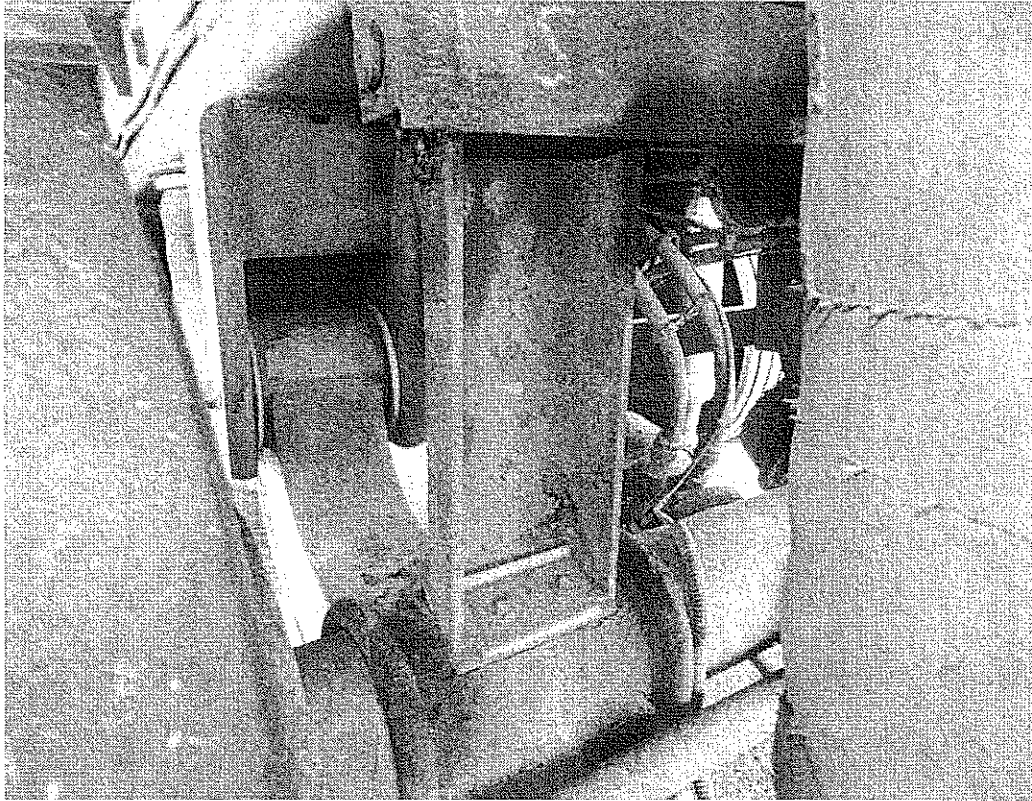
Photo #9

After the driver/operator completes the activities of raising the semi-trailer to dock height, after he/she hears the air springs exhaust of air pressure, he/she is required to inspect that the angle iron wear pads are firmly resting on the axle. If this occurs there is no probability of having the kickstand legs kick out.

This inspection can be simplistically accomplished from several vantage points. First, by looking between the two axles or two sets of tires on the driver-side, then the same process on the curbside. The second vantage point is to look behind the rear most tire at the associated axle #2, as seen in the above photograph #9, then doing the same inspection on the curbside.

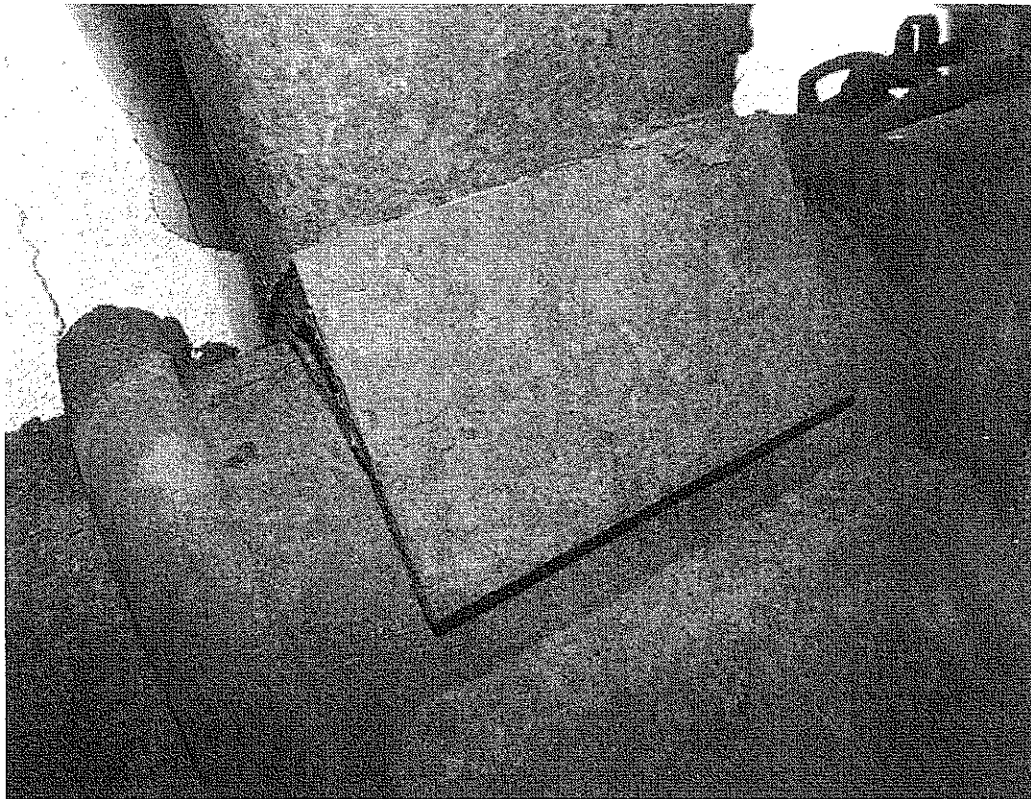
Photo #10

Looking at the reverse angle of the wear pad resting on the axle, the following closer detail photograph is offered:

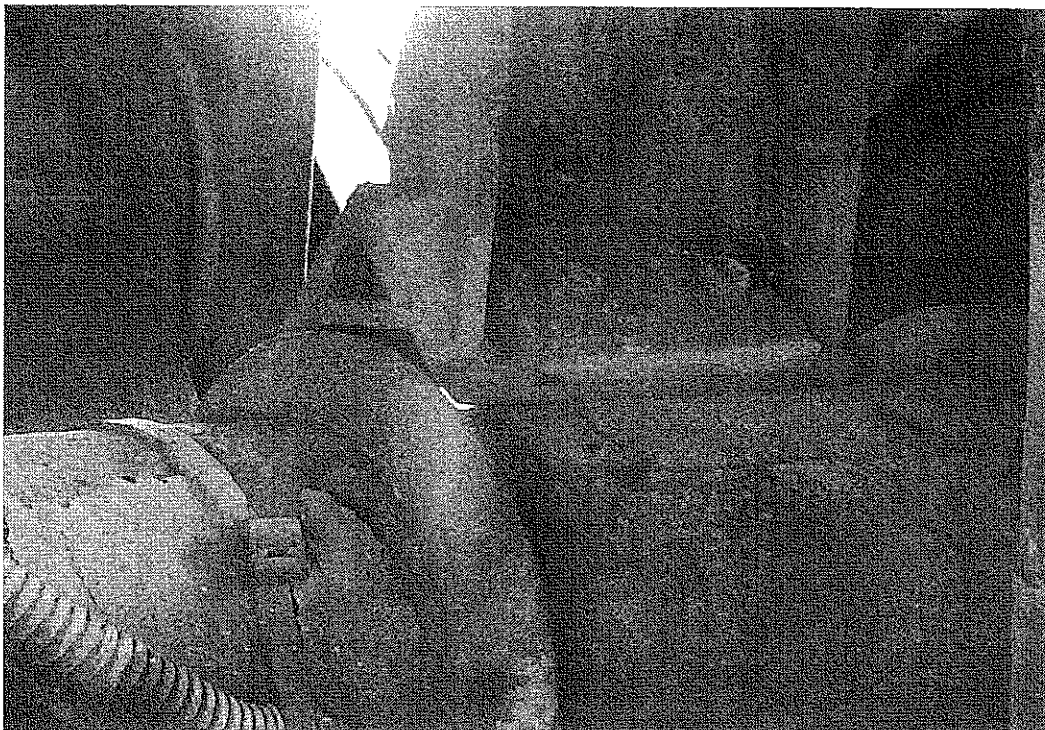
Photo #11

The following photograph points out a few key issues. First, if in fact the wear pads on the bottom of the kickstand legs were not properly seated, as they are in the above photo #9 and #10, there would be a likely collapse of the semi-trailer as the airbags are deflated as part of the Maxi-Lok function. Second, the following photograph #11 clearly demonstrates a kickstand that is not fully seated on the axle. This can be determined based on the position of the kickstand leg; the daylight observed between the wear pad and the axle; and, the difference in oxidation activity where the wear pad rests compared to the adjacent axle surfaces. It must be noted that this condition in photo #11 was intentionally created during the PCI and is not suggested to having been a photo of the actual condition at the time of the incident.

Based on all of the facts of a proper inspection of the kickstand positioning most probably not being performed by Urjiles, and the process of elimination of other factors of causation, it is most probable that the kickstand legs got hung up in a relatively similar position as in photo #11, unbeknownst to Urjiles.

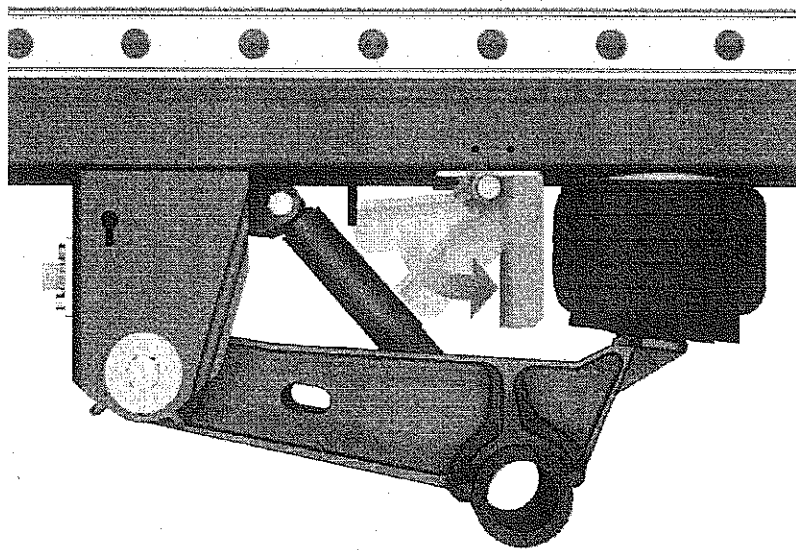
Although the following depiction is that of a SAF Holland Posi-Lok, it is similar in its functionality. The below is offered to give a better understanding to the reader as to how the Maxi-Lok system specifically operates:

The key difference in the Posi-Lok system to that of the Maxi-Lok is the Posi-Lok is designed for a complete automated process without driver intervention. The Maxi-Lok requires driver interaction by air valve operation, further, the control panel door specifically instructs the driver to inspect the kickstand legs. Further, the Posi-Lok is used on standard semi-trailers rather than lowboy trailers such as the Great Dane trailer of subject.

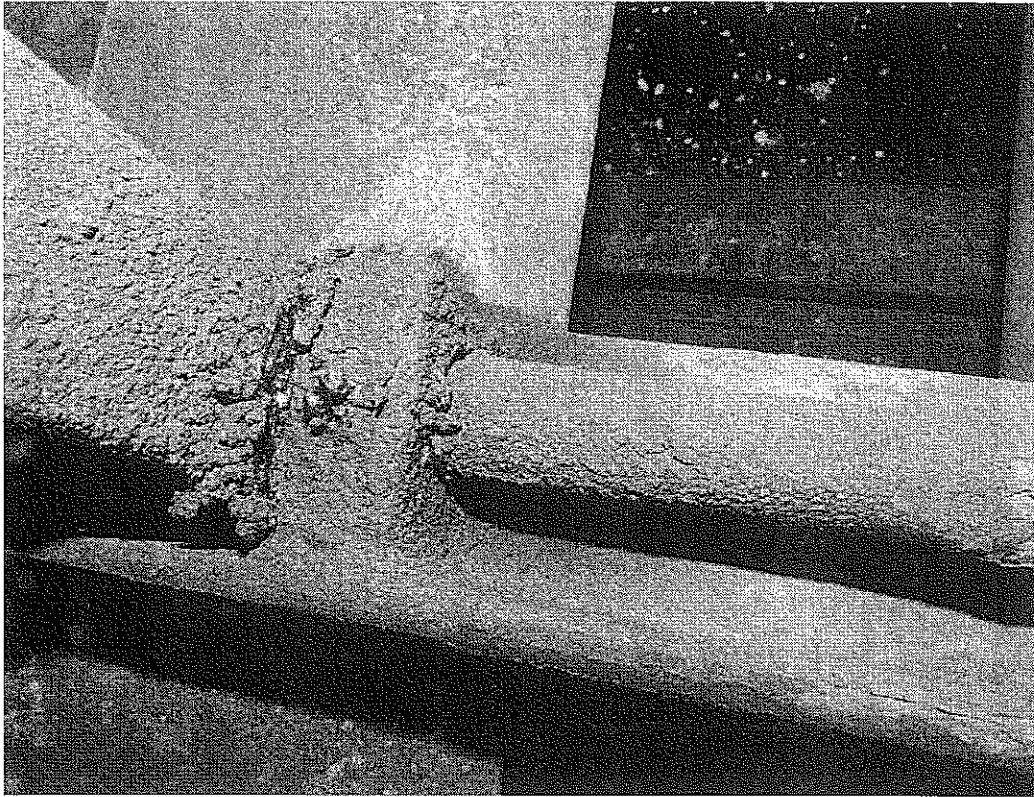
Photo #12

During the PCI it was noted that there was lubrication (grease) on the rod that carries the kickstand legs, however, there was no evidence of fresh grease that would squeeze out of the area intended to be greased, as observed in the following photograph:

Improper grease application, or the failure to grease (lubricate) would result in the intended point of movement that needs lubrication to properly work, it would become hung-up, stiffened or incapable of its full action required. In the absence of lubrication, friction takes over causing restricted and/or resisted movement.

In this case, it most probably resulted in the kickstand legs from reaching their full required swing into the approximate ninety degree right angle position (referenced to the roadway surface), similar to that of photo #9.

8. It is the undersigned's opinion that Dillon failed in its duty to properly and regularly lubricate their CMV, namely the subject Great Dane semi-trailer's Maxi-Lok pivot point and associated grease fittings.
